NASA TM X-1721

ROCKET ENGINE EVALUATION OF EROSION AND CHAR AS FUNCTIONS OF FABRIC ORIENTATION FOR SILICA-REINFORCED NOZZLE MATERIALS

by Donald A. Peterson, Jerry M. Winter,
and Arthur M. Shinn, Jr.

Lewis Research Center
Cleveland, Ohio

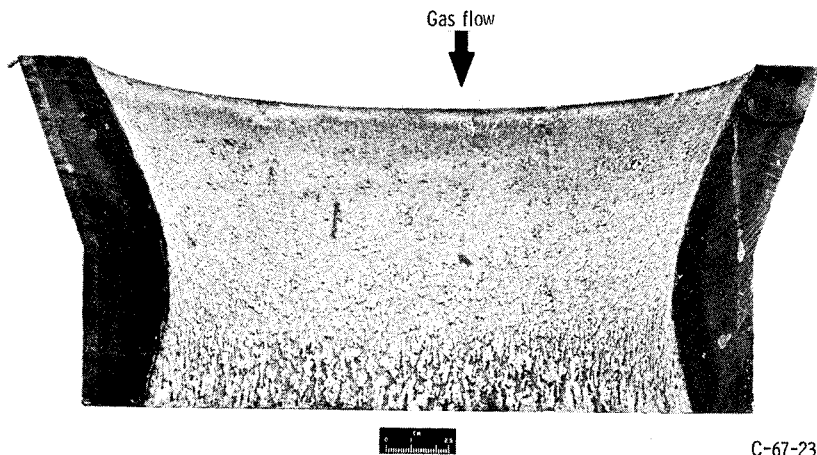
(a) Nozzle 1A; orientation, 30° centerline; 70-percent silicon dioxide - 30-percent phenolic.

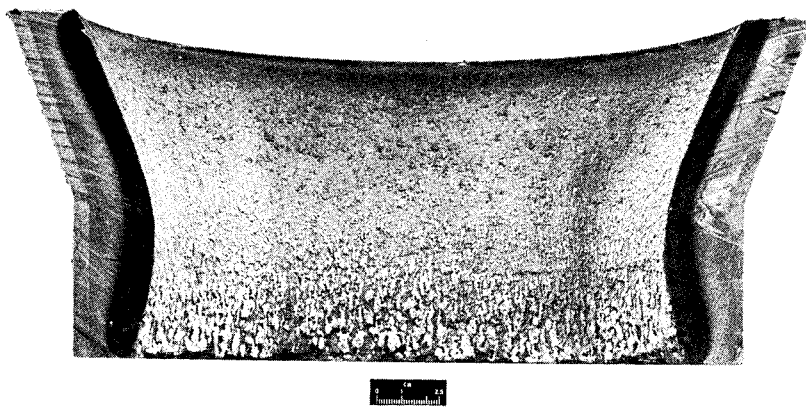
(b) Nozzle 1B; orientation, 60° centerline; 70-percent silicon dioxide - 30-percent phenolic.

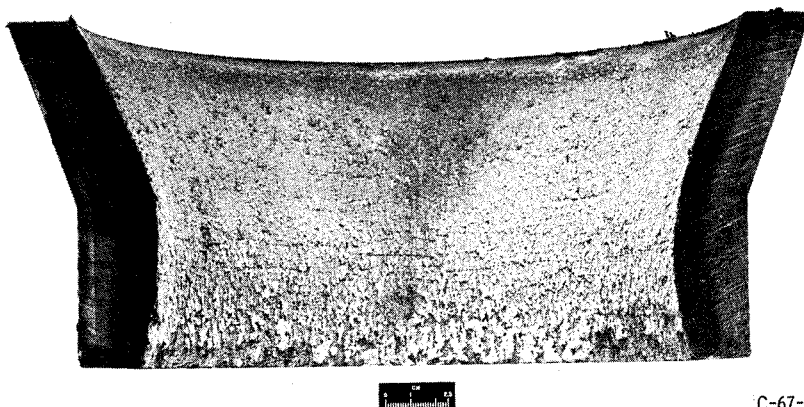
(c) Nozzle 1C; orientation, 90° centerline; 70-percent silicon dioxide - 30-percent phenolic.

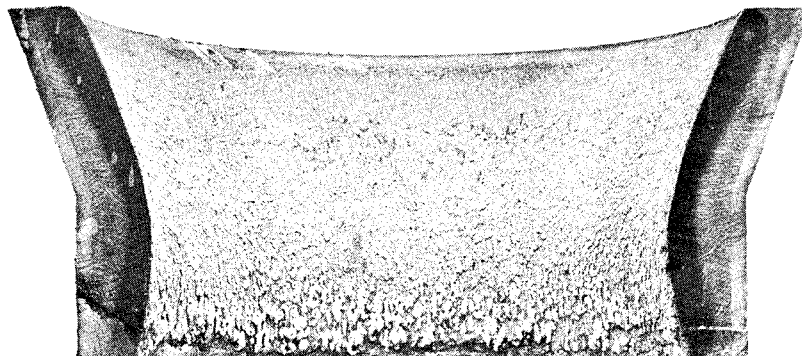
(d) Nozzle 1D; orientation, 1/2 by 1/2 square; 70-percent silicon dioxide - 30-percent phenolic.

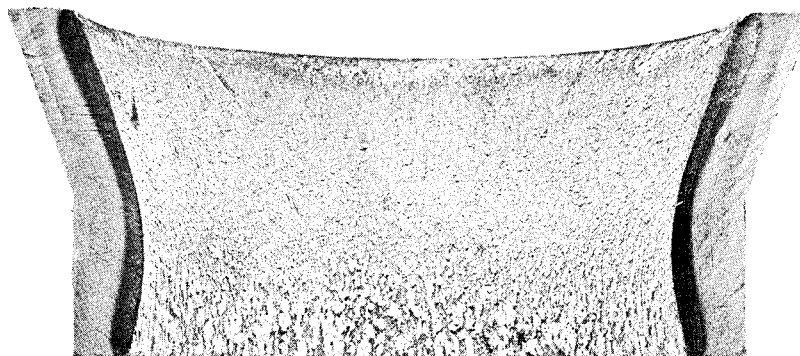
(e) Nozzle 1E; orientation, rosette; 70-percent silicon dioxide - 30-percent phenolic.

The erosion data for material number 1, 30-percent phenolic high silica, are presented in figure 8(a). Five fabric orientations were evaluated. With the exception of the rosette layup, all of the fabric orientations gave comparable results. (The possible reasons for the relatively poor erosion resistance of all the rosette nozzles will be discussed later in this section.) However, a slight advantage was noted for the 60° and random square orientations.

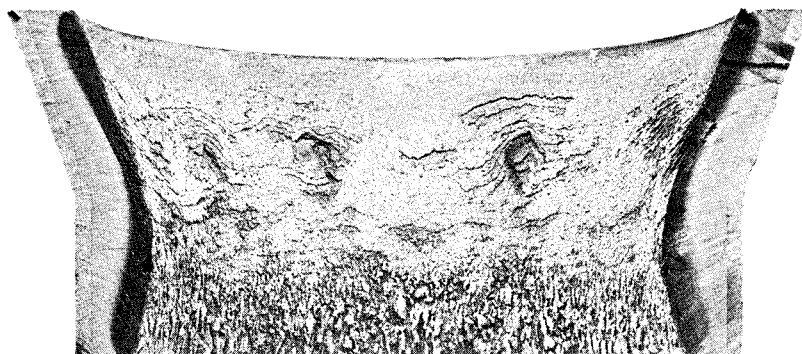
(f) Nozzle 2A; orientation, 30° centerline; 61-percent silicon dioxide - 31-percent phenolic - 8-percent silicon dioxide filler.

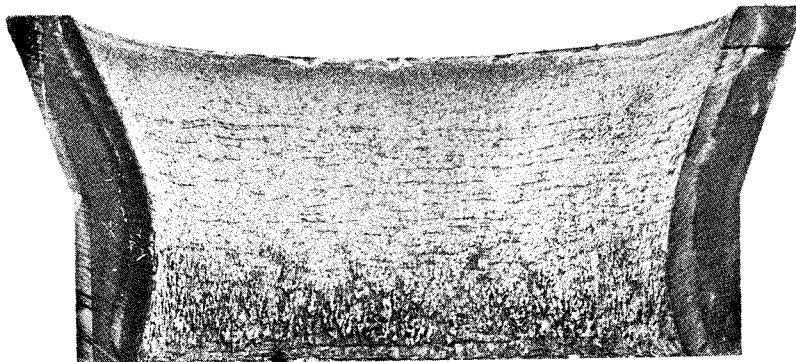
(g) Nozzle 2B; orientation 60° centerline; 61-percent silicon dioxide - 31-percent phenolic - 8-percent silicon dioxide filler.

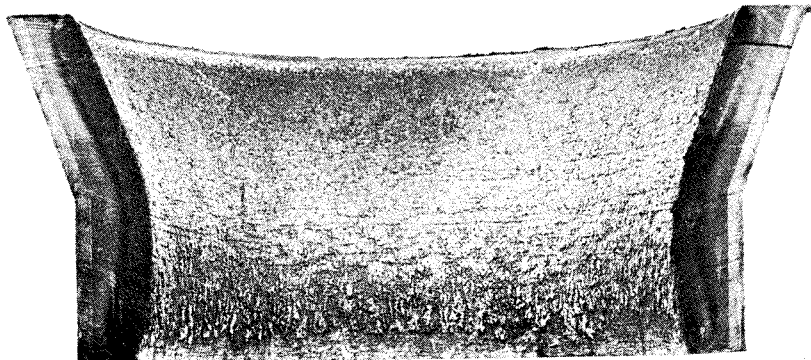
(h) Nozzle 2C; orientation 90° centerline; 61-percent silicon dioxide - 31-percent phenolic - 8-percent silicon dioxide filler.

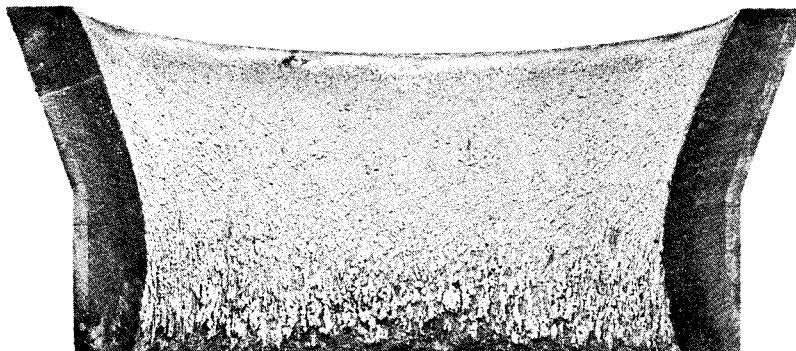
(i) Nozzle 2D; orientation, 1/2 by 1/2 square; 61-percent silicon dioxide - 31-percent phenolic - 8-percent silicon dioxide filler.

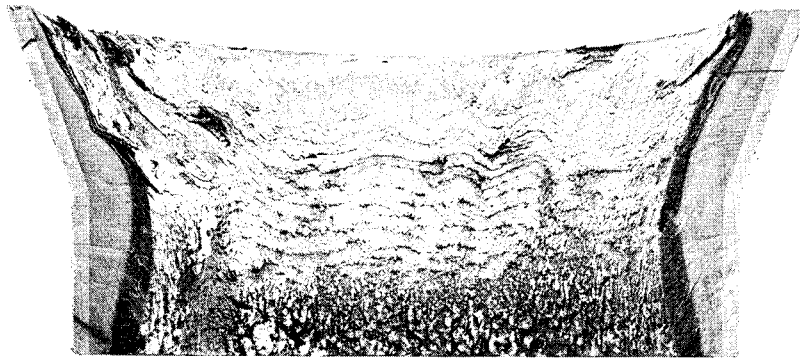
(j) Nozzle 3A; orientation, 30° centerline; 68-percent silicon dioxide - 32-percent phenolic polyamide.

The results for material number 3, a 32-percent phenolic-polyamide resin with high-silica reinforcement, presented in figure 8(c), are similar to those of material 2. The 30° and 60° orientations were superior in erosion resistance to the 90° and random square orientation. The nozzle with 30° orientation was also delaminated upstream of the throat (see fig. 6(j)).

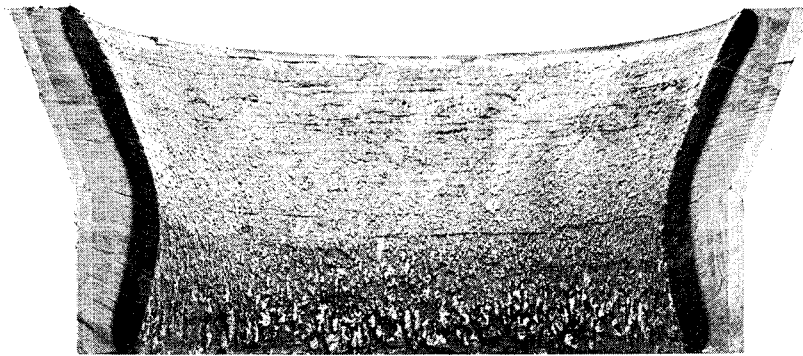
(k) Nozzle 3B; orientation, 60° centerline; 68-percent silicon dioxide - 32-percent phenolic polyamide.

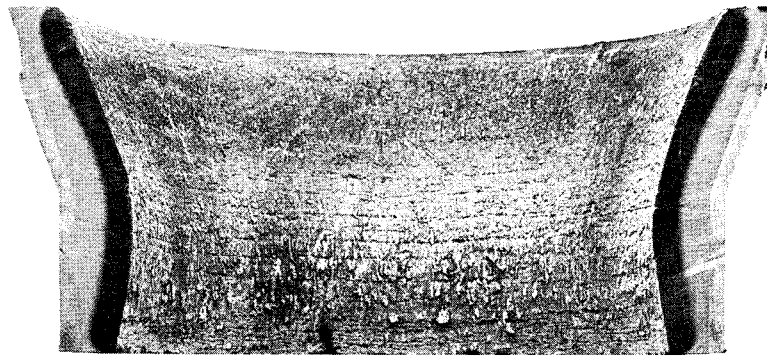
(l) Nozzle 3C; orientation, 90° centerline; 68-percent silicon dioxide - 32-percent phenolic polyamide.

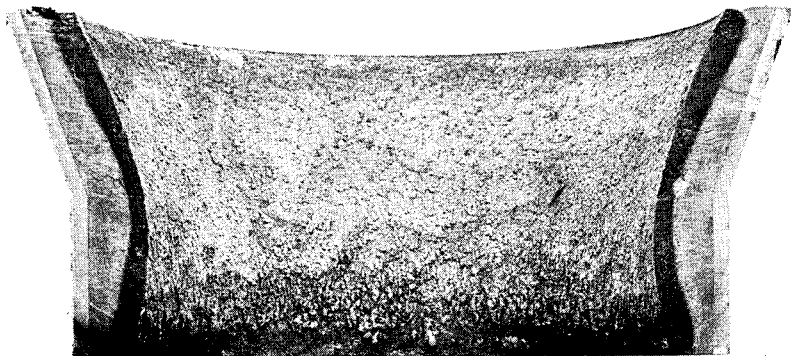
(m) Nozzle 3D; orientation, 1/2 by 1/2 square; 68-percent silicon dioxide - 32-percent phenolic polyamide.

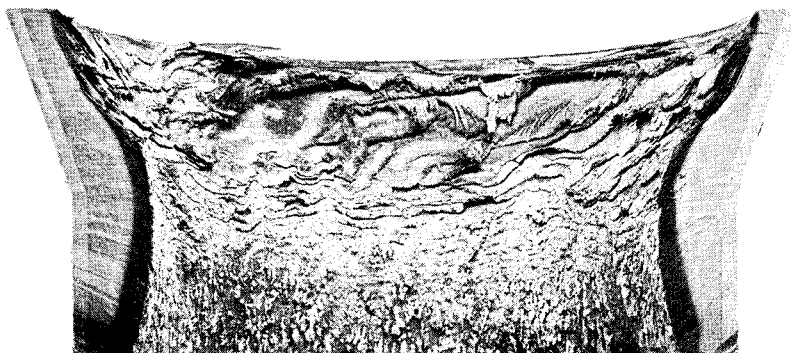
(n) Nozzle 4A; orientation, 30° centerline; 80-percent silicon dioxide - 20-percent phenolic polyamide.

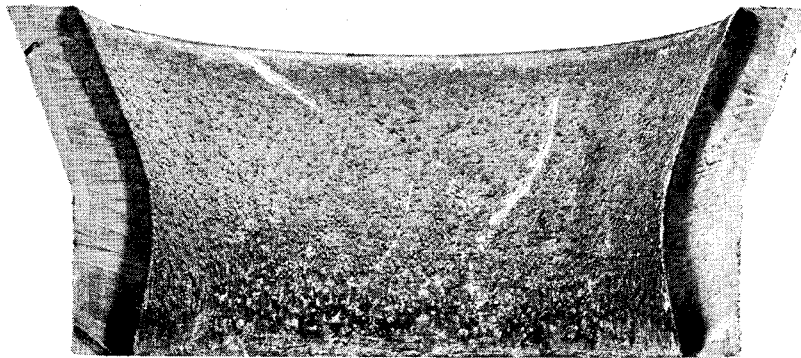
(p) Nozzle 4C; orientation, 90° centerline; 80-percent silicon dioxide - 20-percent phenolic polyamide.

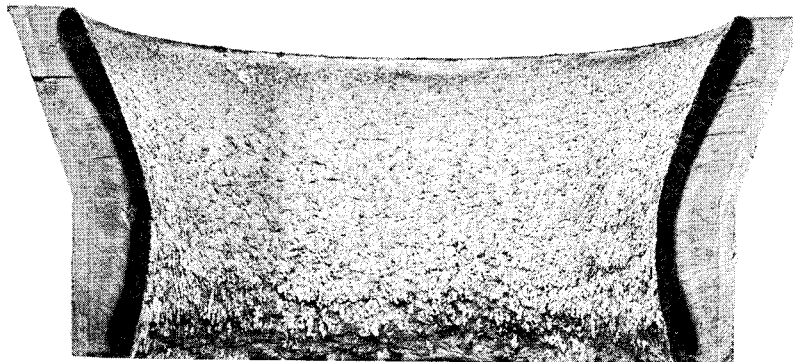
(q) Nozzle 4D; orientation, 1/2 by 1/2 square; 80-percent silicon dioxide - 20-percent phenolic polyamide.

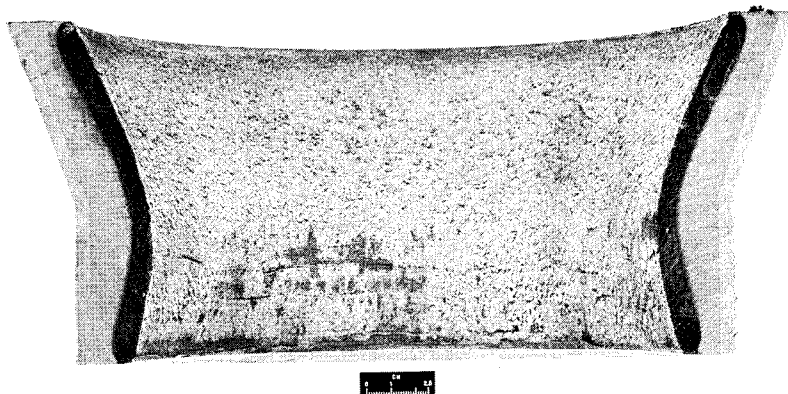
(s) Nozzle 5A; orientation, 30° centerline; 67-percent silicon dioxide - 3 percent chrome sale -
30-percent phenolic.

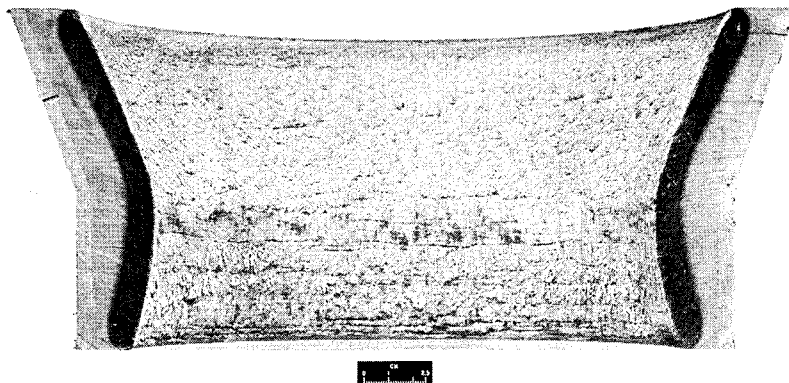
(t) Nozzle 5B; orientation, 60° centerline; 67-percent silicon dioxide - 3-percent chrome salt -
30-percent phenolic.

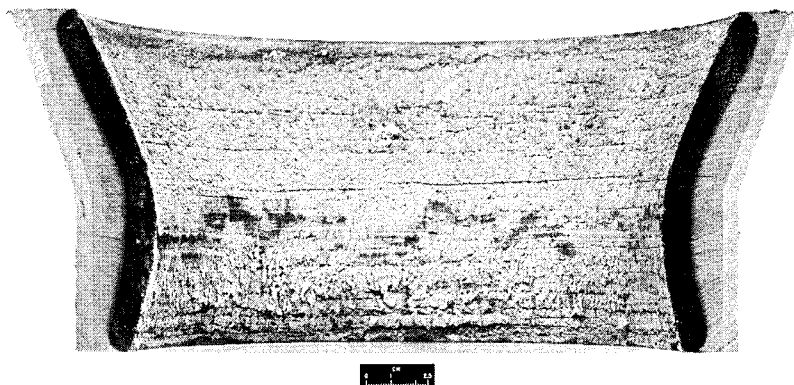
(u) Nozzle 5C; orientation, 90° centerline; 67-percent silicon dioxide - 3-percent chrome salt -
30-percent phenolic.

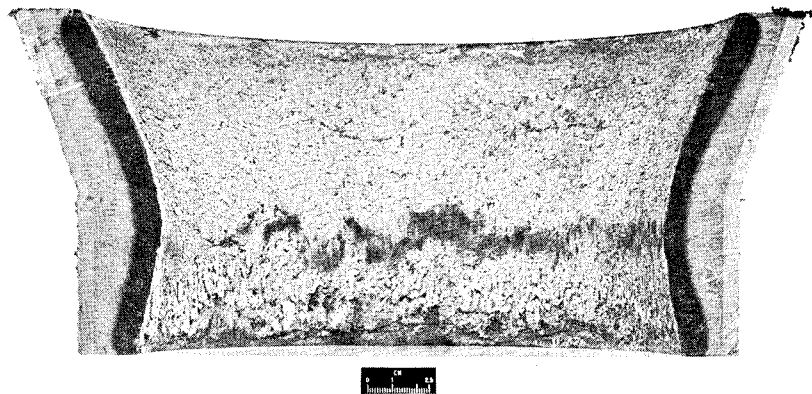
(v) Nozzle 5D; orientation, 1/2 by 1/2 square; 67-percent silicon dioxide - 3-percent chrome salt - 30-percent phenolic.

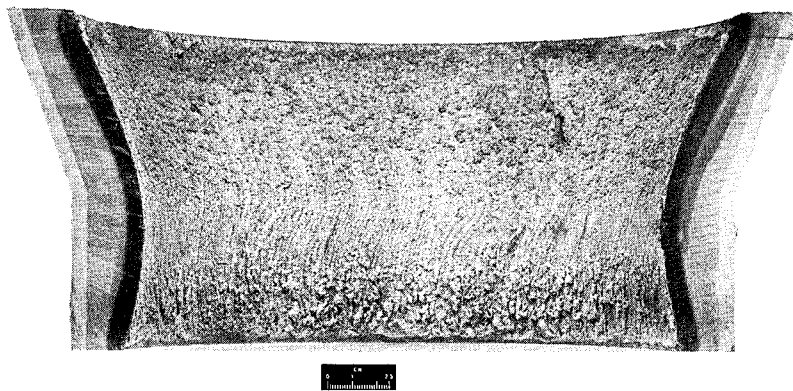
(w) Nozzle 5E; orientation, rosette; 67-percent silicon dioxide - 3-percent chrome salt - 30-percent phenolic.

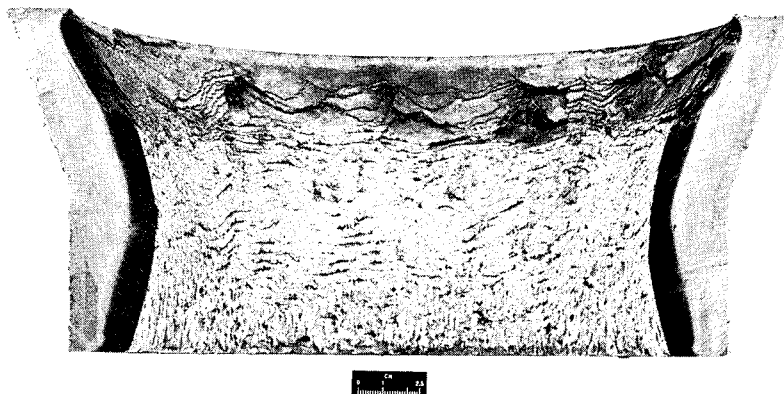
(x) Nozzle 6A; orientation, 30° centerline; 70-percent silicon dioxide - 30-percent modified phenolic.

Figure 8(f) shows the erosion of material 6, a 30-percent modified phenolic with high-silica reinforcement. The 60° fabric orientation had slightly better erosion resistance when compared to all of the other fabric orientations. The 30° layup angle material exhibited severe upstream delamination (fig. 6(x)).

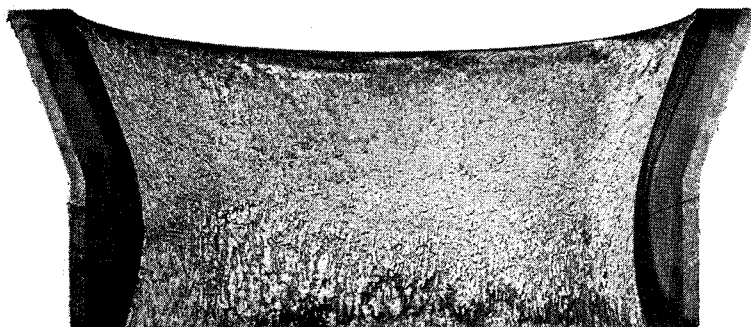
(y) Nozzle 6B; orientation 60° centerline; 70-percent silicon dioxide - 30-percent modified phenolic.

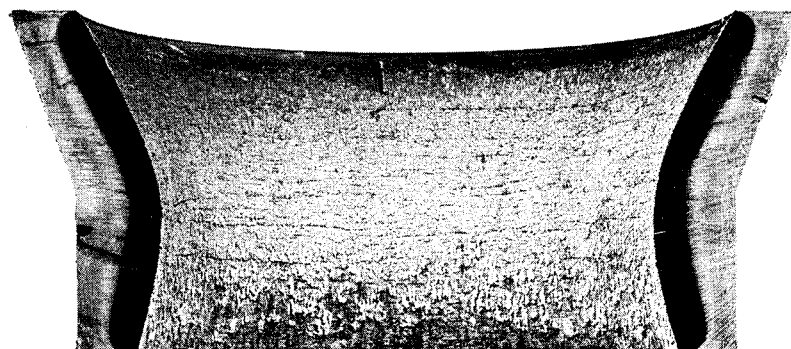
(z) Nozzle 6C; orientation, 90° centerline; 70-percent silicon dioxide - 30-percent modified phenolic.

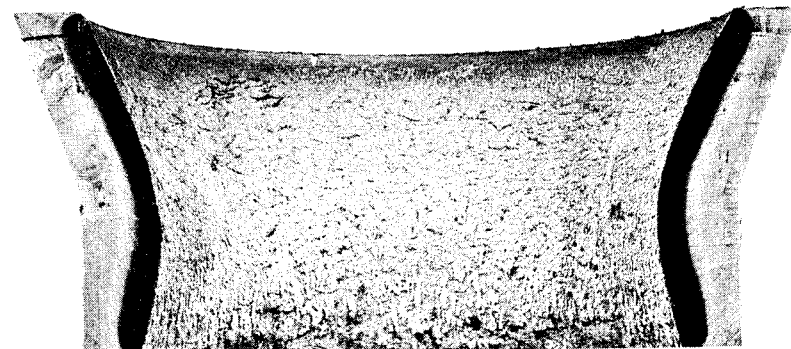
(aa) Nozzle 6D; orientation, 1/2 by 1/2 square; 70-percent silicon dioxide - 30-percent modified phenolic.

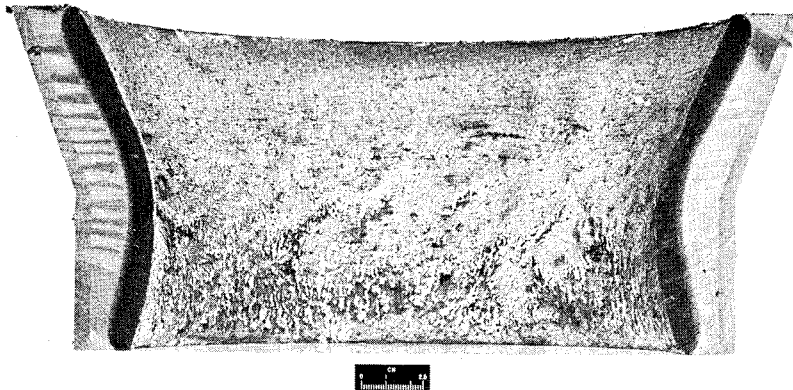
(cc) Nozzle 7B; orientation, 60° centerline; 60-percent silicon dioxide - 40-percent elastomeric phenyl silane.

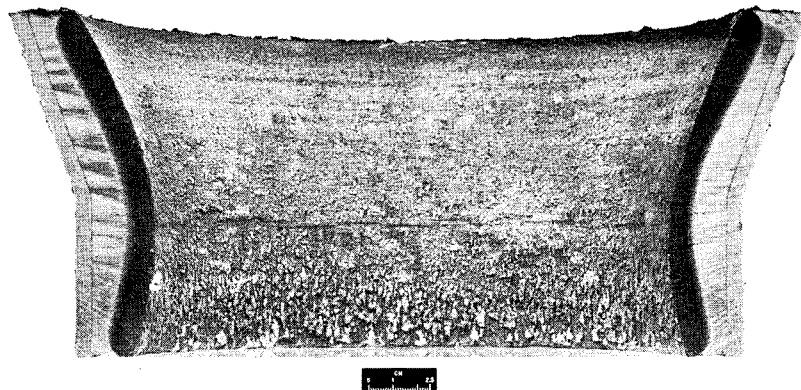
(dd) Nozzle 7C; orientation, 90° centerline; 60-percent silicon dioxide - 40-percent elastomeric phenyl silane.

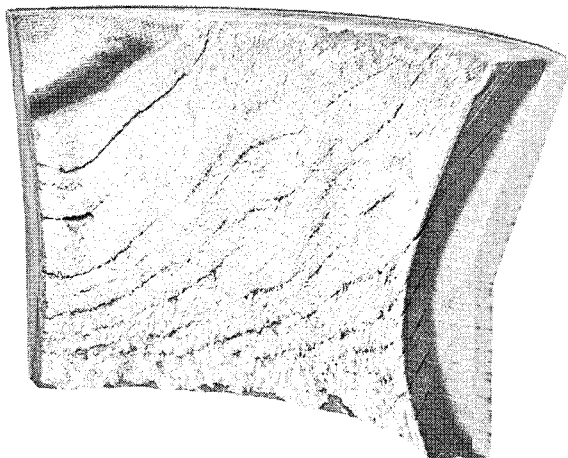
(ee) Nozzle 7E; orientation, rosette; 60-percent silicon dioxide - 40-percent elastomeric phenyl silane.

(ee). A possible cause of the high erosion of all rosette layups may be illustrated by comparing the rosette layup used in reference 1 to the rosette layup used here. A helix angle of approximately 20^O is illustrated in figure 6(ee), above. Figure 6(ee), below, shows a helix angle near 0^O for nozzle 7E. This was typical of all the rosette nozzles. The lack of helix angle also caused the delamination problems experienced with nozzles 4E and 7E.

The unexpectedly poor showing (see ref. 1) of the rosette layup was probably due to the lack of a spiral or helix angle at the throat in these nozzles. Without a helix angle, it is difficult to obtain high interlaminar bond strength together with high overall part density. Decreased shear force resistance results in ply separation and fabric chunking (see fig. 6(ee)).

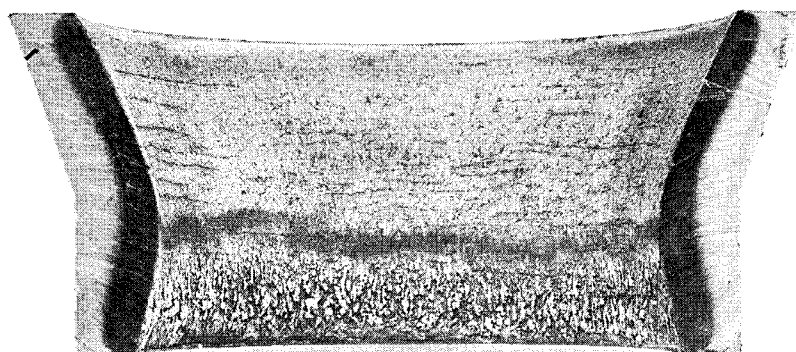
(ff) Nozzle 8B; orientation, 60° centerline; 70-percent silicon dioxide - 30-percent high-temperature phenolic.

The material used for nozzle 8B and 8C was a high-silica fabric impregnated with an experimental high-temperature phenolic type resin. The erosion results are shown in figure 8(h). The 60^O orientation exhibited 25 percent greater erosion resistance than the 90^O orientation. Posttest photographs are shown in figures 6(ff) and (gg).

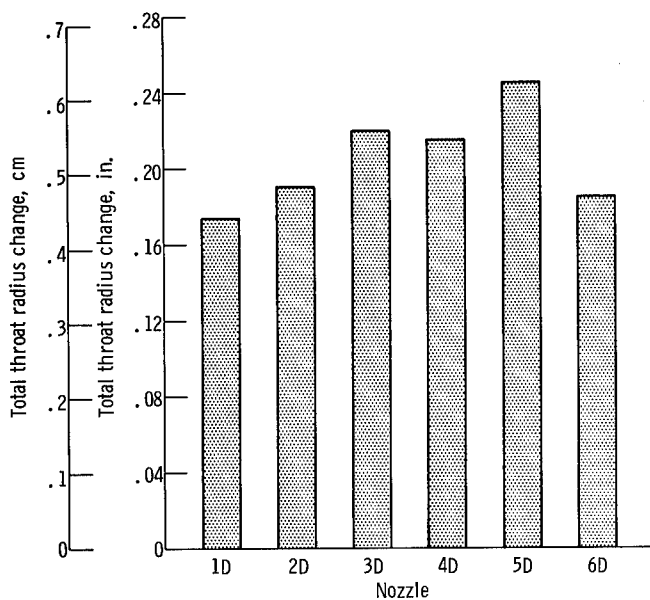
(a) Orientation, 30° centerline.

Figure 10(a) presents the erosion data for the 30^O orientation of materials 1 through 7. Despite delamination upstream of the throat, which probably helped reduce throat erosion, the MX-2600(2A) material was superior in erosion resistance to all other materials tested at this fabric orientation. Nozzles 1A (MX-89) and 5A (MXS-141) were the only ones that did not delaminate during the firing. All other materials delaminated during the firing as is indicated in figure 10(a). A 30^O orientation of the fabric to the nozzle centerline cannot be used when the entrance half angle of the nozzle is 30^O or more. This results in a 0^O orientation to the hot gas flow and is responsible for fabric delamination.

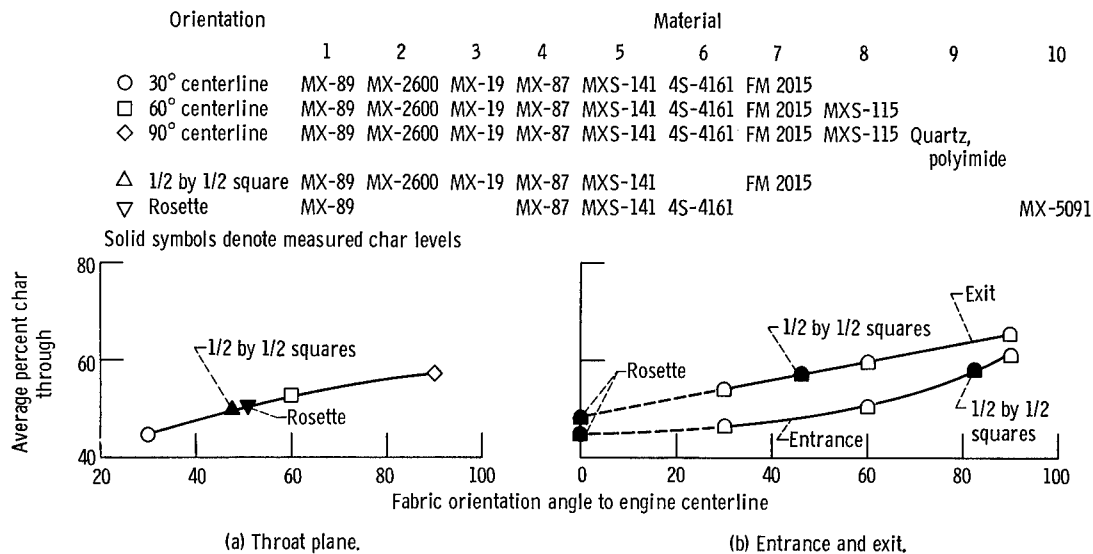
Figure 11. - Ablative char against fabric angle.

The average percent char-through of all nozzles tested has been compared with respect to the fabric orientation angle to the engine centerline. Figure 11(a) shows a curve of the average char-through at the throat plane and figure 11(b) shows the char at both the entrance and exit planes. All three curves have the same general shape. On each curve, the 1/2- by 1/2-inch (1.27- by 1.27-cm) squares and the rosette layup are entered at the measured char level. The 1/2- by 1/2-inch (1.27- by 1.27-cm) squares and the rosette layup appear to be equivalent in percent char-through to a 50^O fabric orientation at the throat plane. The rosette layup for both the entrance and exit planes of the nozzle had the lowest percent char-through and is equivalent to a 0^O fabric orientation if fabric orientation curves are extrapolated.

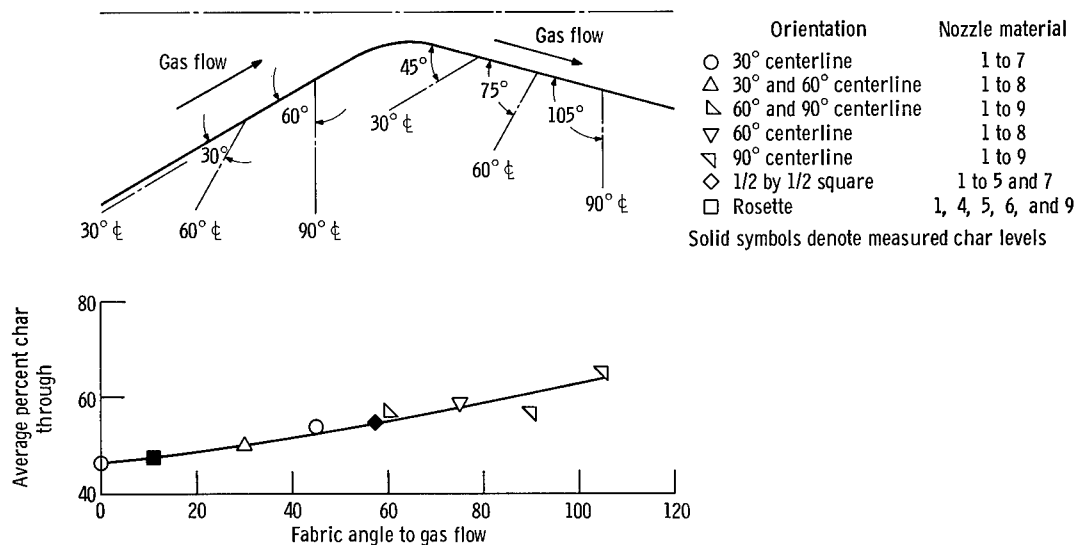
Figure 12. - Ablative char against fabric angle to gas flow.

Since the effective fabric angle differs greatly from entrance to exit, it would seem to indicate that the primary method of charring at constant heat flux might be related to the length of the fabric heat path. The length of the heat path is determined by the angle formed between the internal surface contour of the nozzle and the fabric orientation regardless of the nozzle plane location. The average percent char can then be considered as a function of the fabric orientation angle to the gas flow as in figure 12. A sketch of the nozzle contour is included for clarity. The points shown are averages of all the available data. The curve suggests the desirability of maintaining a low angle of fabric orientation to the gas flow from a char standpoint. Combining minimum char orientation with erosion resistant orientation in the required areas of the nozzle should result in minimum engine weight. The rosette layup as fabricated acted as a 0^O to gas flow orientation because the plies were laid up longitudinally and were radially compressed to effect an almost parallel layup to the gas flow.
